Smoke and Dye Testing Summary

High Level Sewershed

Test ID	Test Type	Date Inspected	Company / Super.	Blower MH	Ground Condition	Notification Made?	Total Length
S1028-269	Smoke	9/2/2009	ADS/TM	S11MM1016MH	Dry	Yes	701.36

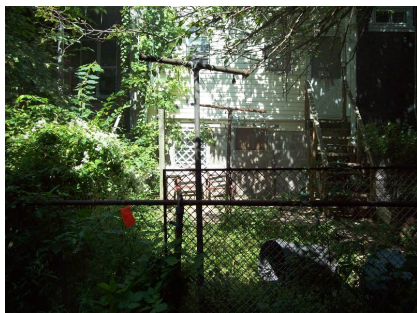
Picture \S1028-269-OB01-P01.jpg

Source Service Lateral

Location Yard - back

Comments Smoke from service lateral in back yard. 3109 Virginia Ave.

Comments Back of house, 3109 Virginia Ave.

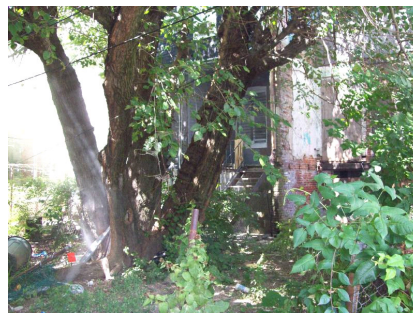
Picture \S1028-269-OB02-P01.jpg

Source Cleanout

Location Yard - back

Comments Smoke from cleanout in back yard. 3105 Virginia Ave.

Comments Back of house, 3105 Virginia Ave.

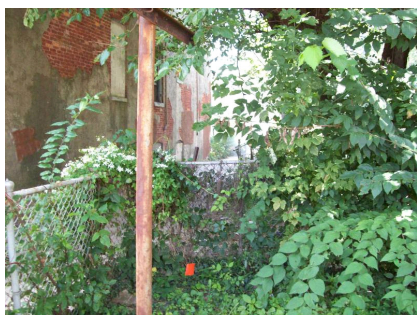
Picture \S1028-269-OB03-P01.jpg

Source Service Lateral

Location Yard - back

Comments Smoke from service lateral in back yard. 3103 Virginia Ave.

Comments Back yard, 3103 Virginia Ave.

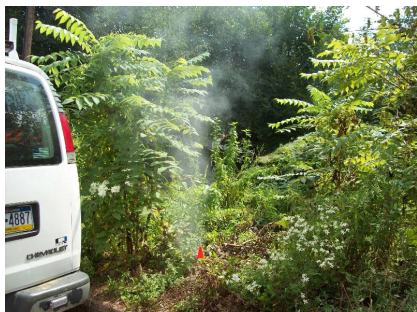
Picture \S1028-269-OB05-P01.jpg

Source Cleanout

Location Yard - back

Comments Smoke from cleanout in back yard. 4669 Delaware Ave.

Comments Back yard, 4669 Delaware Ave.

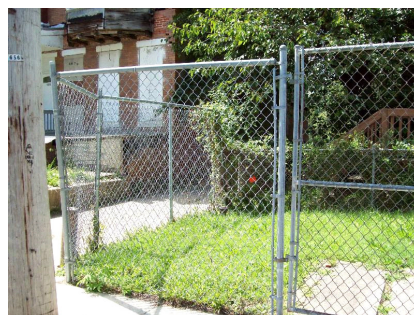
Picture \S1028-269-OB04-P01.jpg

Source Service Lateral

Location Yard - back

Comments Smoke from service lateral in back yard. 3101 Virginia Ave.

Comments Back of house, 3101 Virginia Ave.

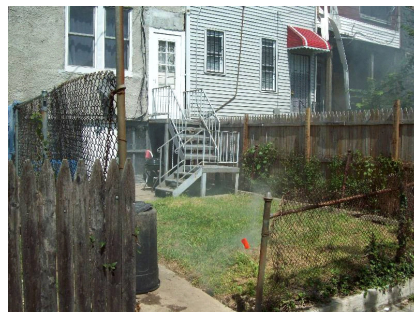
Picture \S1028-269-OB06-P01.jpg

Source Service Lateral

Location Yard - back

Comments Smoke from service lateral in back yard. 3123 Virginia Ave.

Comments Back of house, 3123 Virginia Ave.

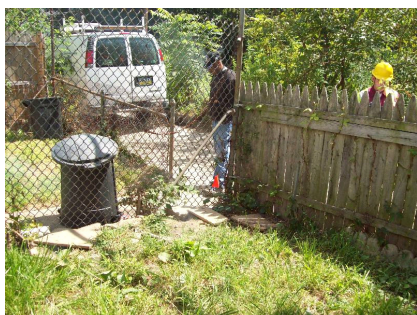
Picture \S1028-269-OB07-P01.jpg

Source Service Lateral

Location Yard - back

Comments Smoke from service lateral in back yard. 3125 Virginia Ave.

Comments Back yard, 3125 Virginia Ave.

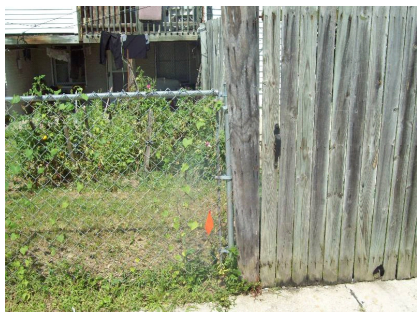
Picture \S1028-269-OB09-P01.jpg

Source Service Lateral

Location Yard - back

Comments Smoke from service lateral in back yard. 3131 Virginia Ave.

Comments Back of house, 3131 Virginia Ave.

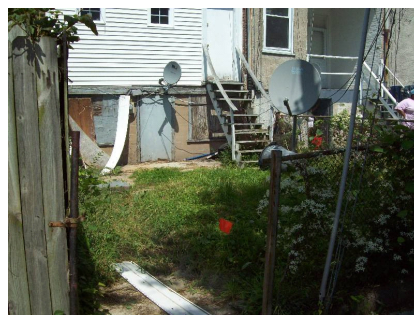
Picture \S1028-269-OB08-P01.jpg

Source Service Lateral

Location Yard - back

Comments Smoke from service lateral in back yard. 3127 Virginia Ave.

Comments Back of house, 3127 Virginia Ave.

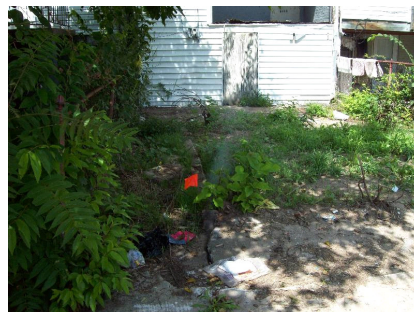
Picture \S1028-269-OB10-P01.jpg

Source Service Lateral

Location Yard - back

Comments Smoke from service lateral in back yard. 3133 Virginia Ave.

Comments Back of house, 3133 Virginia Ave.

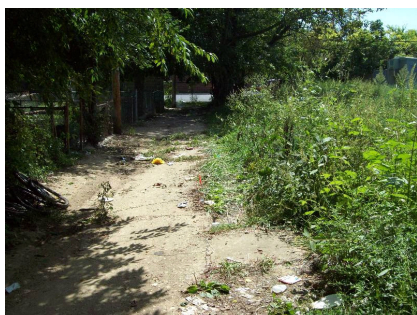
Picture \S1028-269-OB11-P01.jpg

Source Service Lateral

Location Field / woods

Comments Smoke from service lateral in empty lot. 4661 Delaware Ave.

Comments Back of lot, 4661 Delaware Ave.

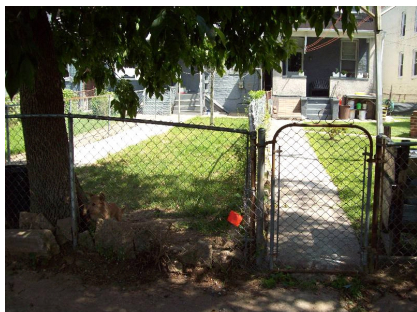
Picture \S1028-269-OB13-P01.jpg

Source Service Lateral

Location Yard - back

Comments Smoke from service lateral in back yard. 4656 Pimlico Rd.

Comments Back of house, 4656 Pimlico Rd.

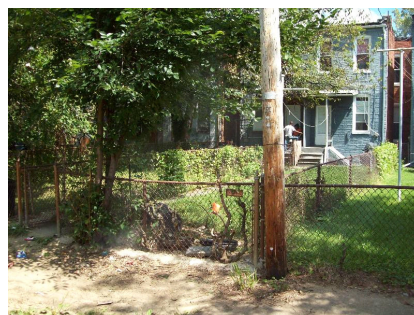
Picture \S1028-269-OB12-P01.jpg

Source Service Lateral

Location Paved concrete

Comments Smoke from service lateral in paved concrete behind house. 4660 Pimlico Rd.

Comments Back of house, 4660 Pimlico Rd.

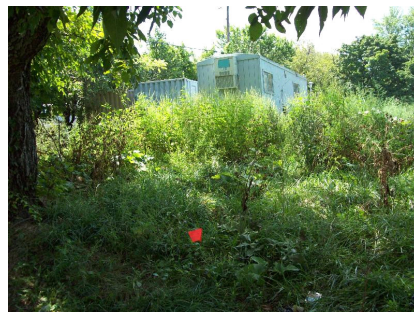
Picture \S1028-269-OB14-P01.jpg

Source Service Lateral

Location Field / woods

Comments Smoke from service lateral in empty lot. 4653 Delaware Ave.

Comments Back of lot, 4653 Delaware Ave.

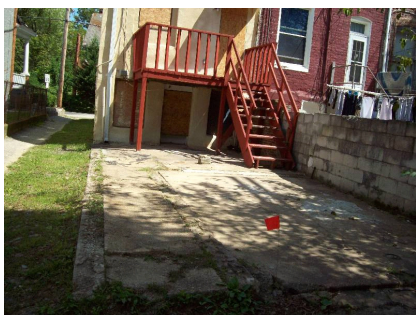
Picture \S1028-269-OB15-P01.jpg

Source Service Lateral

Location Paved concrete

Comments Smoke from service lateral in paved concrete behind house. 4652 Pimlico Rd.

Comments Back of house, 4652 Pimlico Rd.

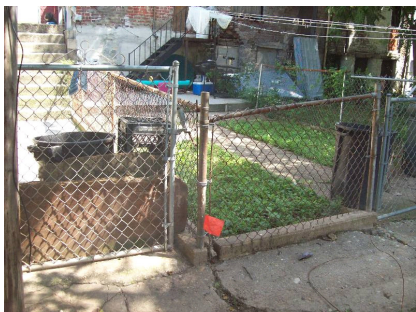
Picture \S1028-269-OB17-P01.jpg

Source Service Lateral

Location Paved concrete

Comments Smoke from service lateral in paved concrete behind house. 4648 Pimlico Rd.

Comments Back of house, 4648 Pimlico Rd.

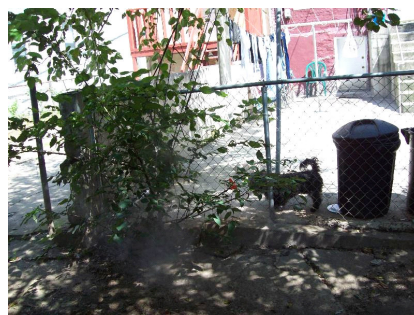
Picture \S1028-269-OB16-P01.jpg

Source Service Lateral

Location Paved concrete

Comments Smoke from service lateral in paved concrete behind house. 4650 Pimlico Rd.

Comments Back of house, 4650 Pimlico Rd.

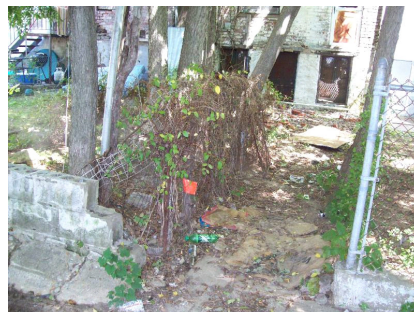
Picture \S1028-269-OB18-P01.jpg

Source Cleanout

Location Yard - back

Comments Smoke from cleanout in back yard. 4644 Pimlico Rd.

Comments Back of house, 4644 Pimlico Rd.

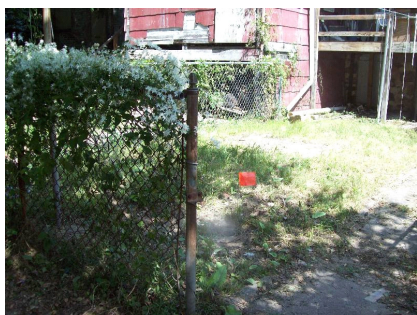
Picture \S1028-269-OB19-P01.jpg

Source Cleanout

Location Yard - back

Comments Smoke from cleanout (missing cap) in back yard. 4630 Pimlico Rd.

Comments Back of house, 4630 Pimlico Rd.

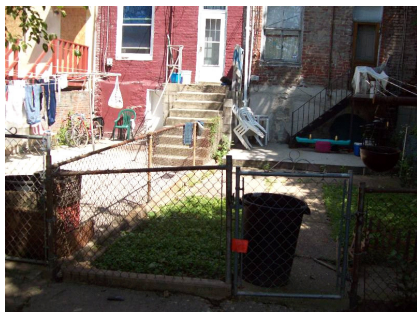
Picture \S1028-269-OB21-P01.jpg

Source Service Lateral

Location Paved concrete

Comments Smoke from service lateral in paved concrete behind house. 4646 Pimlico Rd.

Comments Back of house, 4646 Pimlico Rd.

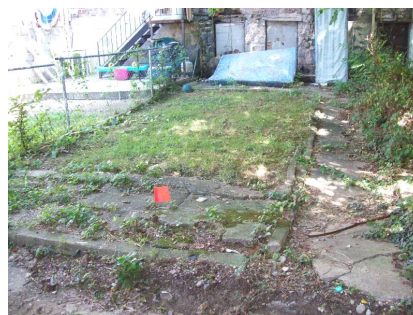
Picture \S1028-269-OB20-P01.jpg

Source Service Lateral

Location Yard - back

Comments Smoke from service lateral in back yard. 4648 Pimlico Rd.

Comments Back of house, 4648 Pimlico Rd.

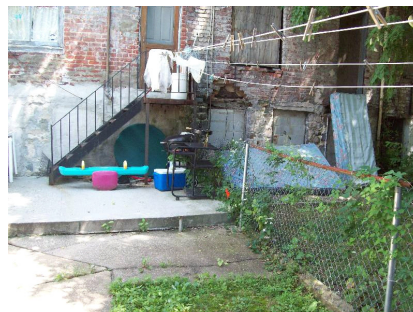
Picture \S1028-269-OB22-P01.jpg

Source Service Lateral

Location Yard - back

Comments Smoke from service lateral in back yard. 4646 Pimlico Rd.

Comments Back of house, 4646 Pimlico Rd.
